INVENTORY FORM FOR STATE HISTORIC SITES SURVEY

TILDEN LAWN

STREET & NUMBER North side MD. Rt. 214

DAVIDSONVILLE X VICINITY OF

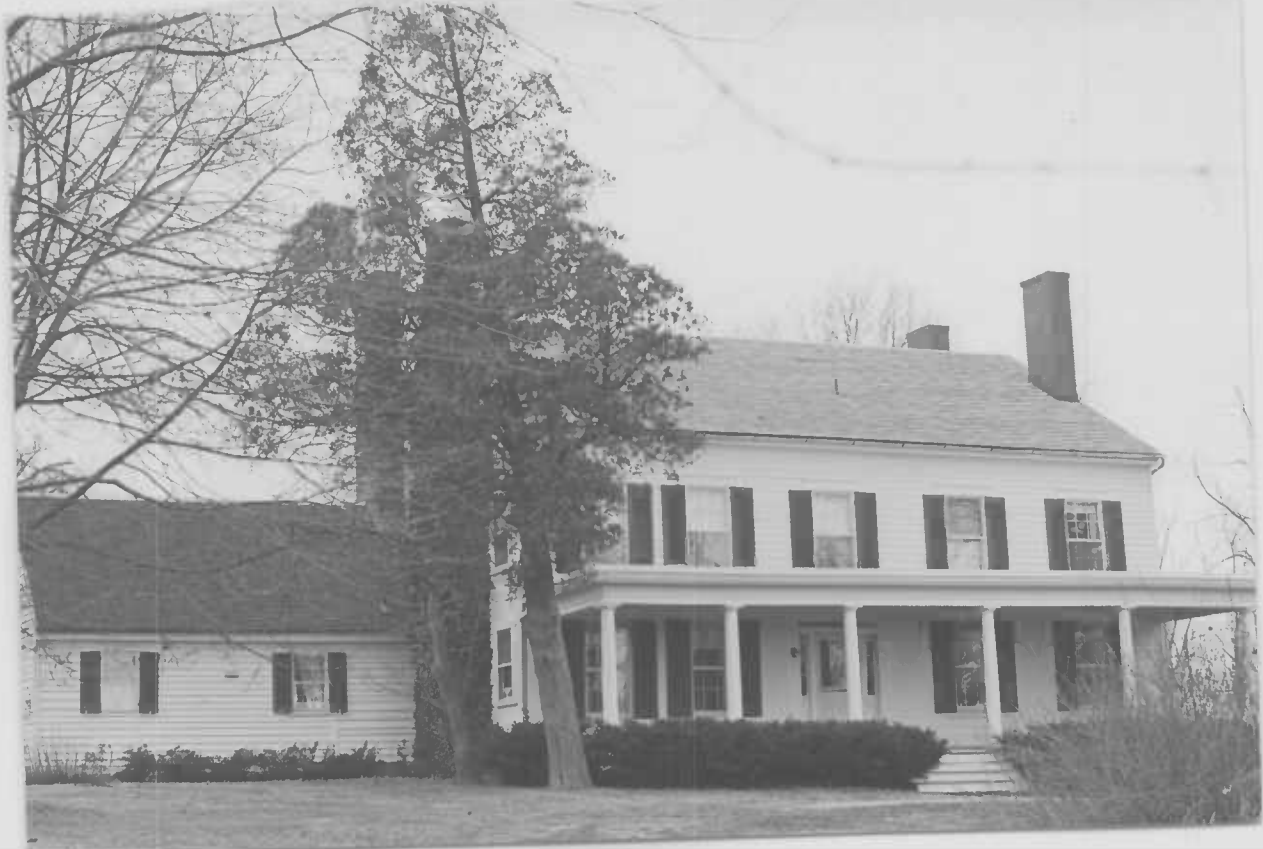
AA'
203

East Elevation

The front facade of the enlarged house faces east. The principal entrance is located in the center bay, framed with sidelights and a four-light transom and flanked by two large 6/6 windows on each side. Five 6/6 windows are ranged across the second story; there are no dormer windows on the roof. The entire front facade was renovated when the house was enlarged. The front door and all of the windows date to the third quarter of the 19th century, and the siding and cornice were also replaced at that time. A more radical change was made to the roof of the original section. The height of the front facade was increased and the early steeply pitched roof was concealed below a higher, more moderately pitched gable roof, now covered with asphalt shingles. The early roof, still covered with wood shingles, remains in place and is visible from the attic. The one story open porch with simple columns was probably added in the early 20th century. The continuous brick foundation of the porch conceals the house foundation. The foundation of the original section is laid in three-course common bond, the later section in random common bond. Notable details on the front facade include the Victorian paneling below the sidelights of the front door, the molded wood window lintels, beaded cornerboards and the box cornice with simple crown mold and bed mold.

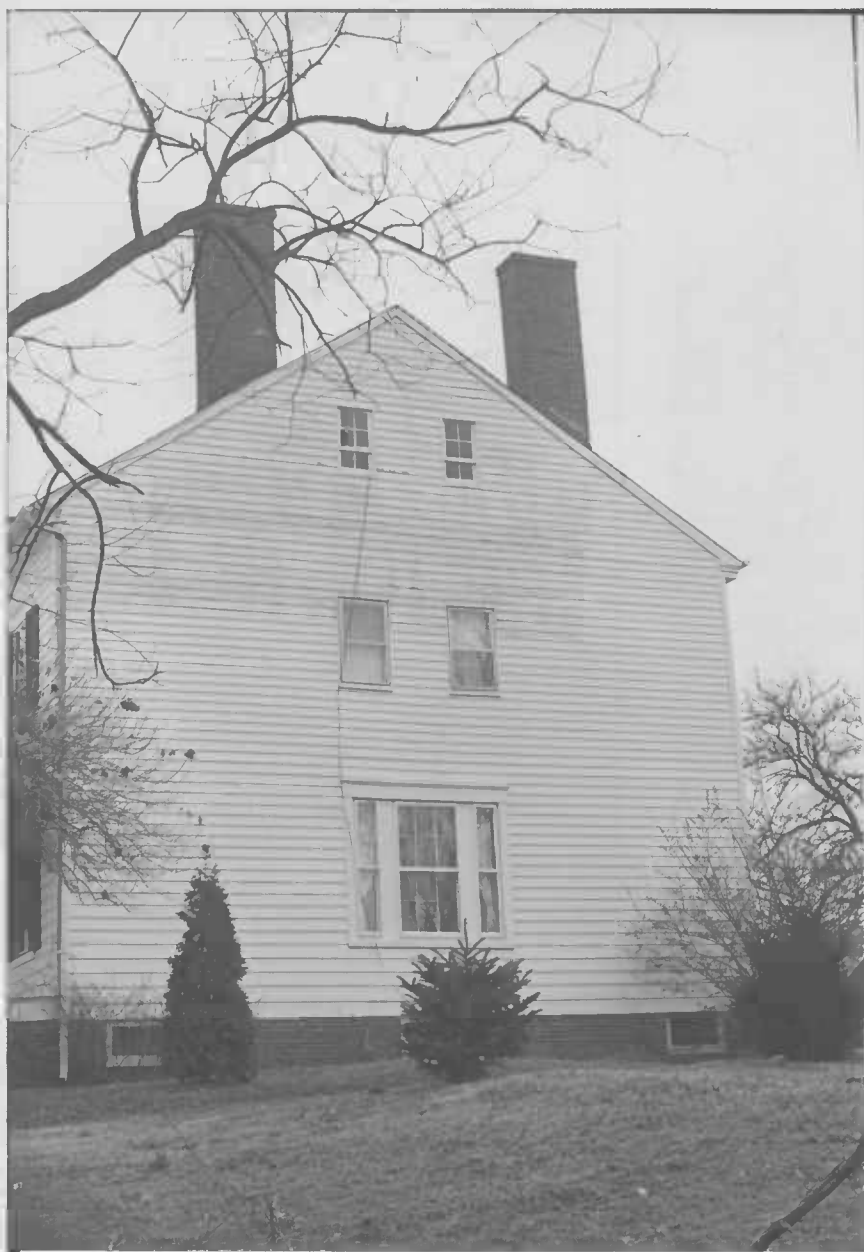
AA
203

North Elevation

On the north gable wall, dating entirely to the second period of construction, there is a large triple window on the first story, a pair of 6/6 windows on the second story and a pair of 4/2 windows in the upper gable. All of the window openings are located between the paired flush chimneys. The triple window on the first floor consists of 6/6 sash in the center flanked with single 2/2 sash on either side. Three three-light cellar windows pierce the brick foundation, which is laid in five-course bond. The plain weatherboard siding matches the front facade. The gable eaves are trimmed with unbeaded, tapered rakeboards.

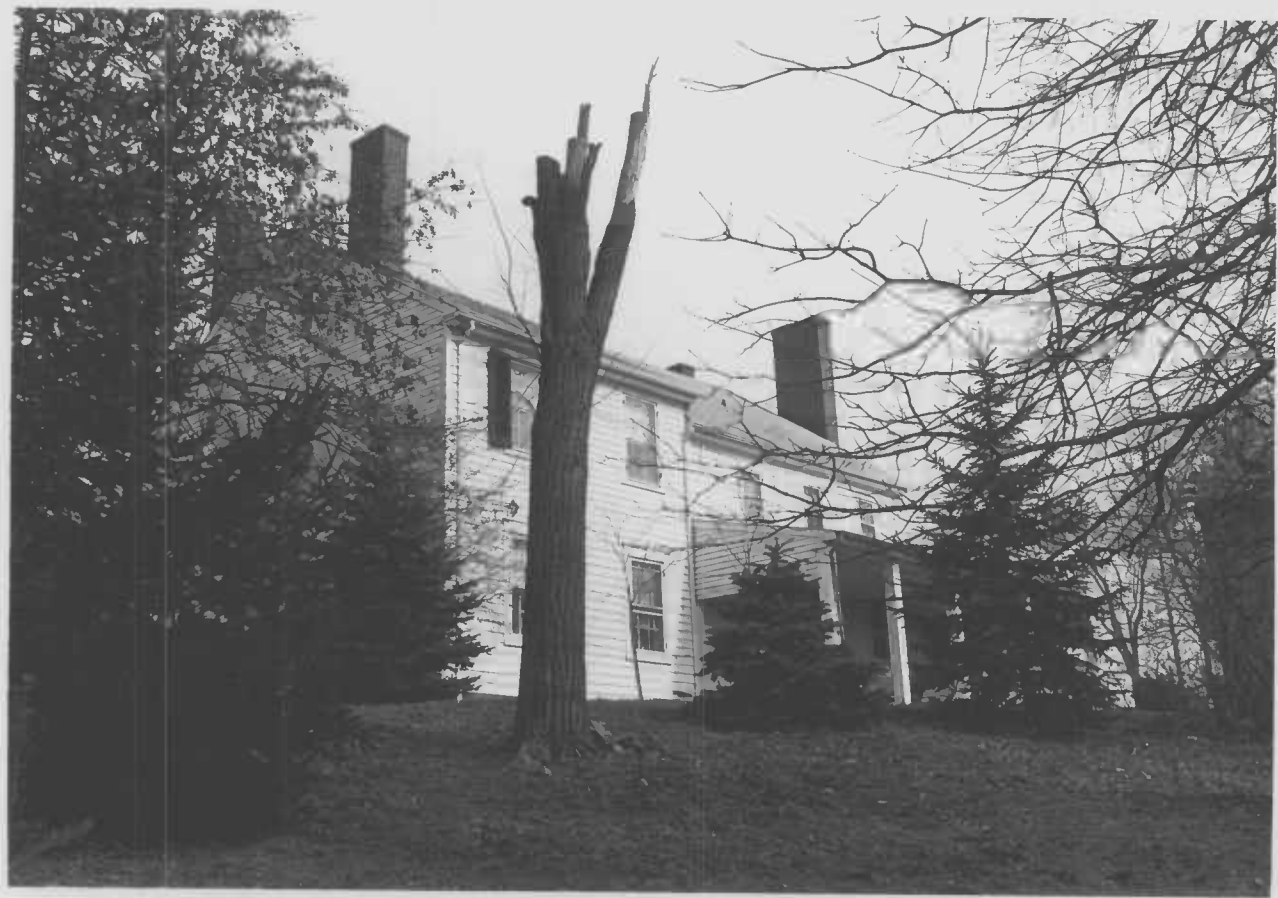
AA-203

Rear facade from Northwest

The one story frame wing is set flush with the rear or west facade of the main house and measures approximately 26 feet long and 18½ feet deep. It rests on a very low concrete or stuccoed brick foundation and is covered with plain weatherboards and an asphalt shingle roof.

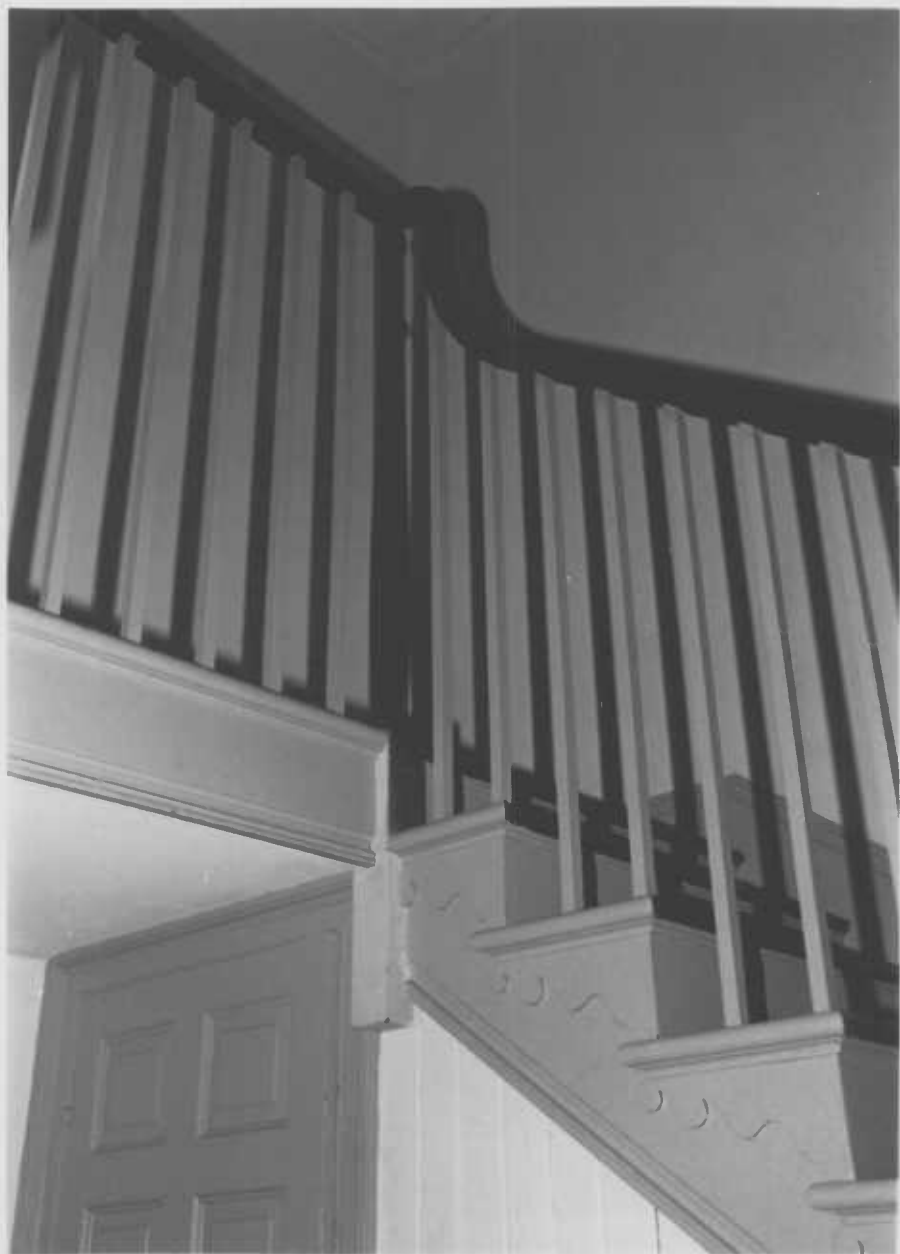
AA-203

First floor stair.

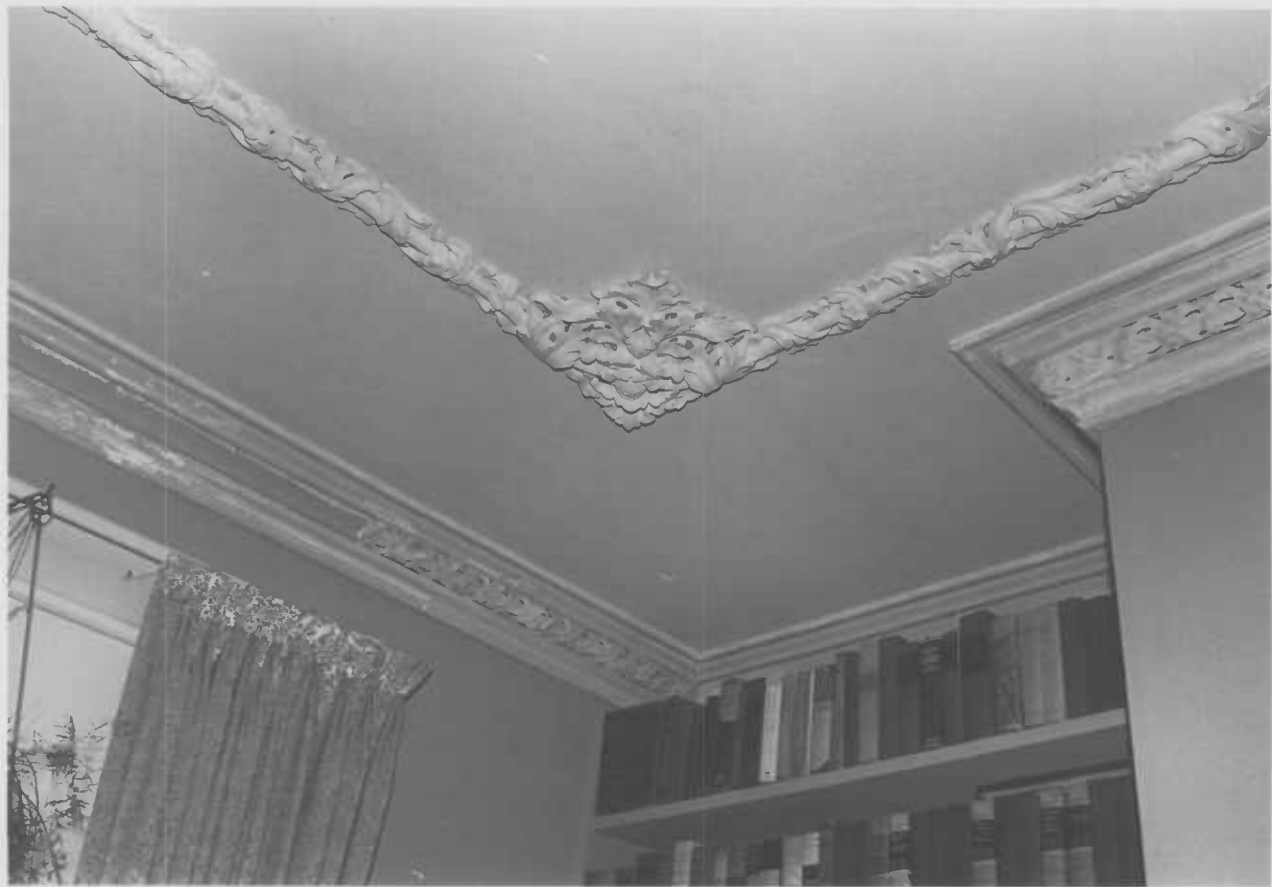
AA-203

Decorative plaster cornice and ceiling,
North room, first floor.

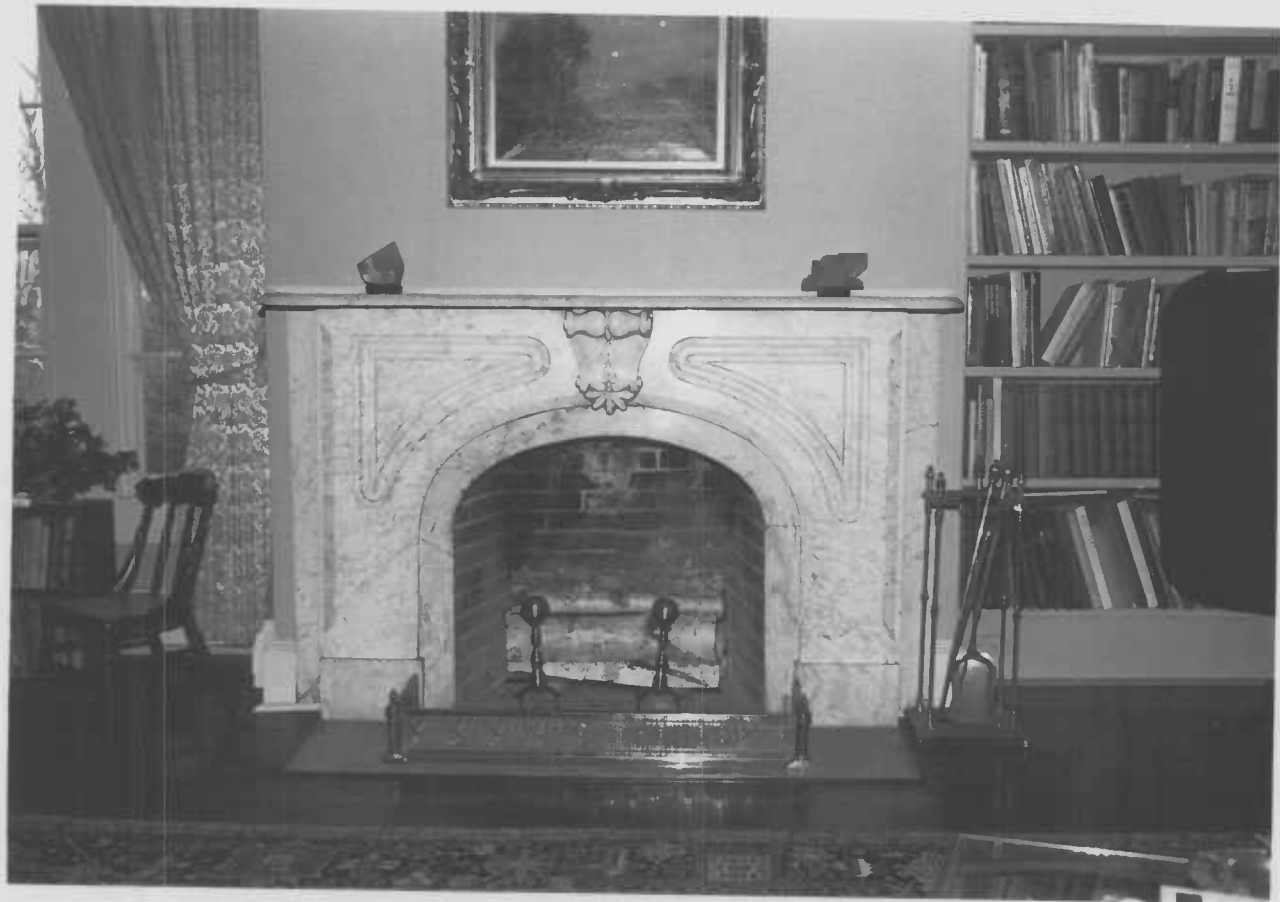
AA-203

Tilden Lawn
Davidsonville, Anne Arundel County, MD.
1982
Orlando Ridout V
Marble mantel in North room, 1st floor.
